CENTRAL INTELLIGENCE AGENCY

SUBJECT Stendal Airfield

EAST GERMANYAIR/MILITARYSTENDAL AIRFIELD - Reconstruction
progress as at 26 July 57.

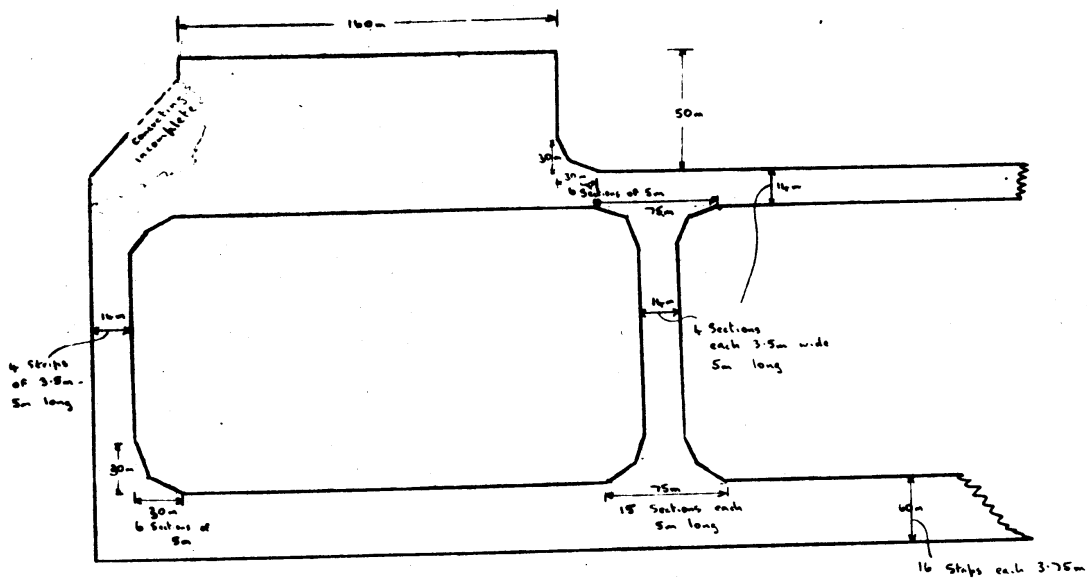
APPENDIX A

To date seven extensive concrete fillets have been laid down at the western end of the runway/taxiway (see sketch at Appendix "A"). The fillets have been constructed in two parts, an initial [] portion, to which a further [] portion has been added, giving the hypotenuse a slight indentation. The two fillets at either end of the inner transverse taxiway, combined with the width of the taxiway itself, have an overall face length of [] 15 sections. Similar [] fillets have been added to the inside of the outer transverse taxiway, and also to the eastern side of the new hardstanding nearing completion in the NW corner. The corresponding fillet on the western side has not yet been completed.

Method of Constructing
Runway/Taxiway Fillets

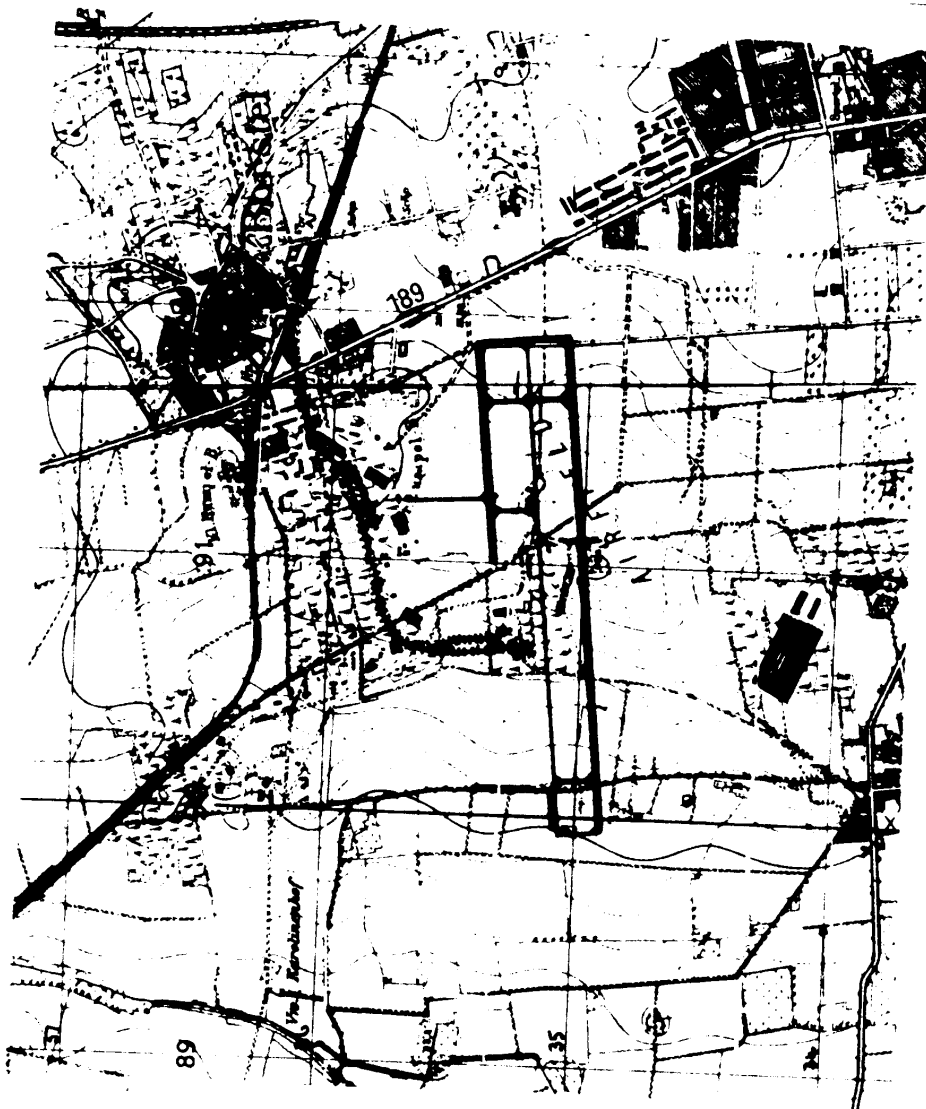
Attached at Appendix "B" is an overlay from local 1/25000 maps showing relative layout of the runway and parallel taxiway with the projected associated hardstandings.

There are indications at present that the base is being levelled off in a uniform fashion (see overlay at Appendix "B" for exact location). The spoil from this excavation is being transferred to the western end of the airfield for use as under-packing in association with the foundations to the northern parallel taxiway. No building material is visible anywhere in the vicinity of this excavation, nor are there any current rumours circulating around the site associated with any proposed bunker construction.
